HISTORIC STRUCTURE REPORT:
THE CUSTOM HOUSE AND TOWER

VOLUME II:
EXISTING CONDITIONS AND RECOMMENDATIONS

SARA B. CHASE
and
ANNE A. GRADY

SOCIETY FOR THE PRESERVATION OF
NEW ENGLAND ANTIQUITIES
CONSERVATION CENTER

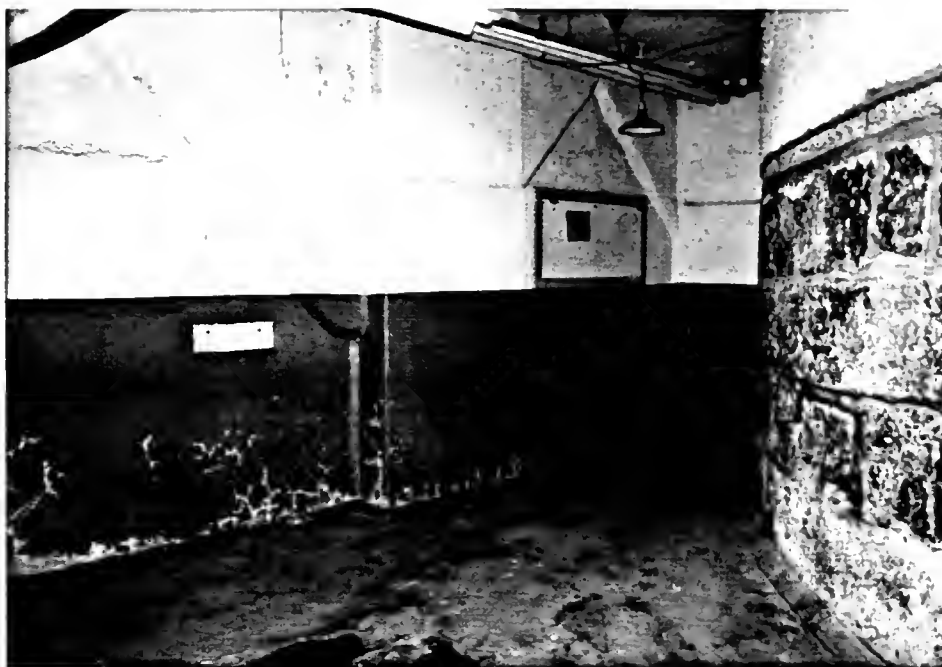
Material/Description		Condition	Photo#
Base-board	none		
Walls	granite, brick, plaster	painted; fair - good	SB-3
Cornice	none		
Ceiling	plaster	fair; peeling paint and skim coat	SB-7
Windows	none		
Window Frames	none		
Doors	none (?)		
Door Frames	metal	painted iron; OK	
Hardware			
Elect. Fixt.			
Special Features			
Remarks

SB-3; Storage room, southeast of rotunda.
Note 1837 rotunda wall (right) and 1912 wall
containing tower substructure (left).

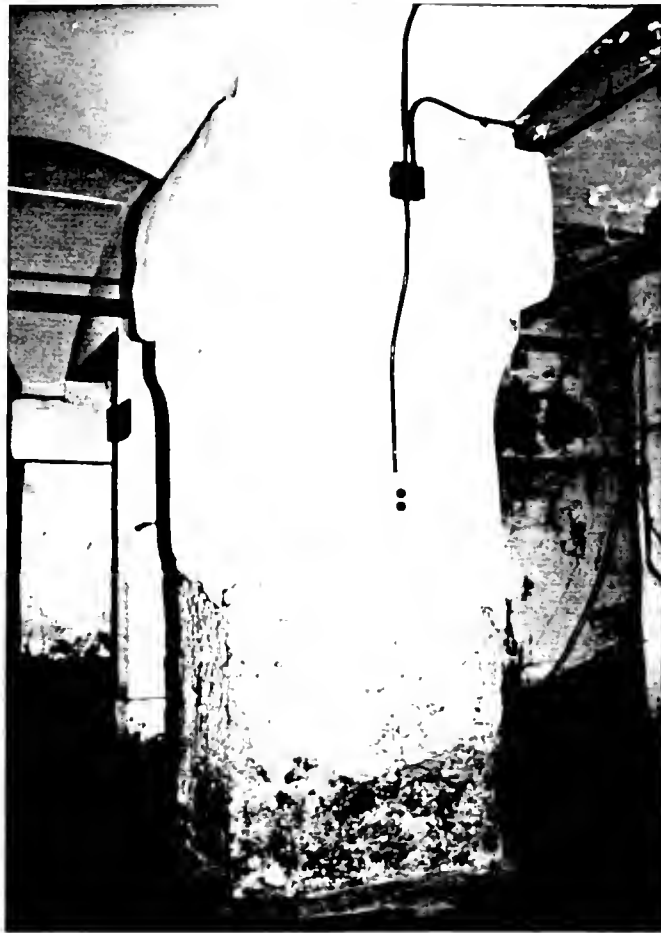
Material/Description		Condition	Photo#
Floor	concrete	poor; <u>standing water</u> in 90% of this area	SB-4
Base-board	none		
Walls	granite, brick	fair; painted and in places plastered	
Cornice	none		
Ceiling	plaster	fair; poor - Paint peeling	SB-5
Windows	none		
Window Frames	sidewalk light frames are iron	very rusted	
Doors	none		
Door Frames	none		
Hardware	none		
Elect. Fixt.	egg crate		
Special Features			
Remarks

SB-5; 1837 granite pier and vault springing, south wing.

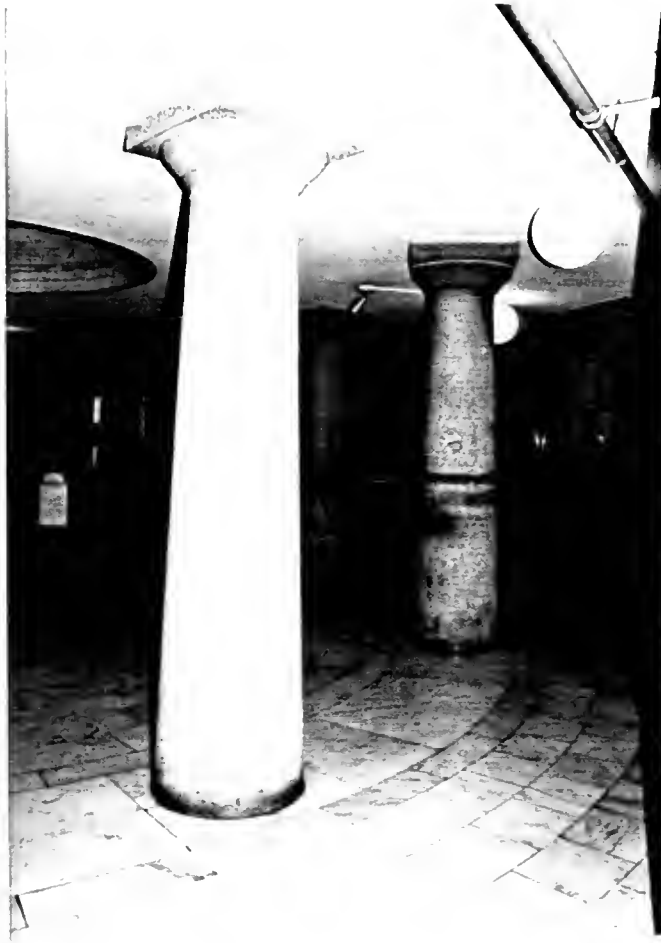
Material/Description		Condition	Photo#
Floor	white marble	good, but somewhat soiled with all joints blackened	B-1 B-18
Base-board	none		
Walls	granite	irregularly soiled, joints generally sound, some bad reprinting	B-2
Cornice	granite	fine, a bit dusty	B-15
Ceiling	flat plaster under gallery	good	B-1, 18, 1-4
Windows	none		
Window Frames	none		
Doors	oak (N & S only)	minor cleaning and touch-up varnish	
Door Frames	oak (N & S only)	(same as above)	
Hardware	brass	fine, but polish has spread onto wood	
Elect. Fixt.			
Special Features	granite columns	very soiled, especially at bases	B-1
Remarks: Signs have marred the granite walls in many areas; new grapevine joints not appropriate.

B-1; Rotunda.

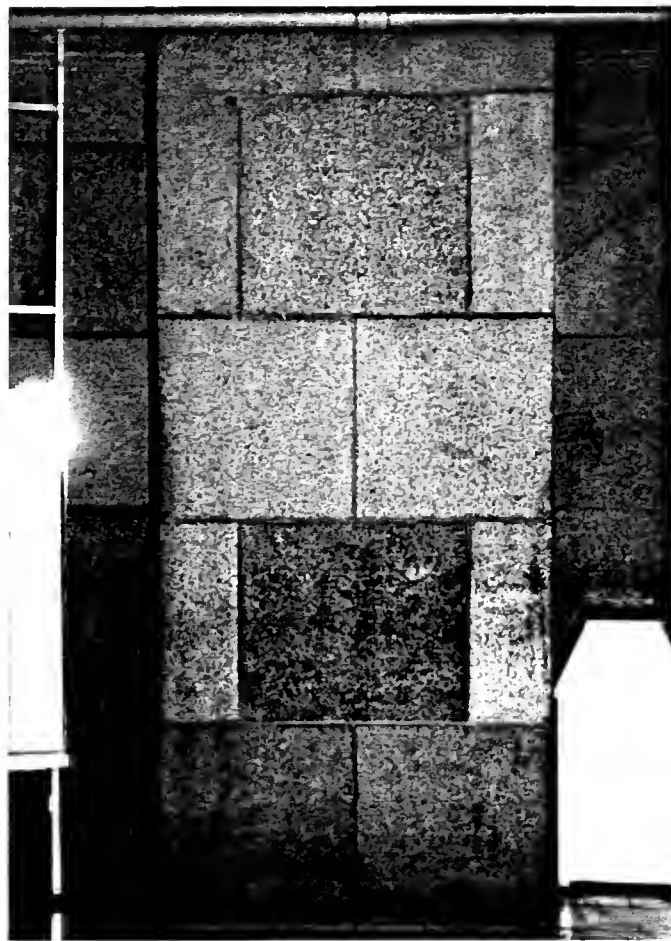
B-2; Rotunda, northeast wall.

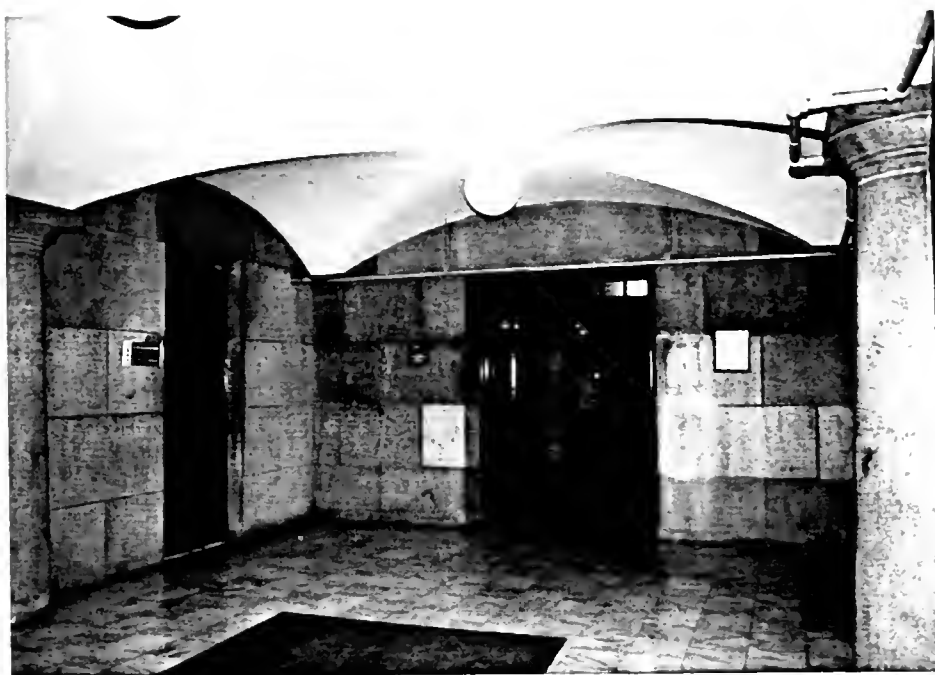
Element	Material/Description	Condition	Photo#
Floor	marble	dirty, joints blackened, holes by rotunda door	B-5, 6
Base-board	none		
Walls	granite	general dirt, plus blackened wax at base	B-5, 6
Cornice	none		
Ceiling	plaster, vaulted	minor cracks and paint peeling	B-5, 6
Windows	none		
Window Frames	none		
Doors	exterior; oak interior; grained metal	exterior: caked brass polish around hardware, crazed finish	B-7, 8
Door Frames	exterior; oak interior; grained metal	need some cleaning and refinishing	
Hardware	brass	fine; some is tarnished	
Elect. Fixt.	frosted spheres	good	
Special Features			
Remarks

Element	Material/Description	Condition	Photo#
Floor	marble	highly waxed, joints dark, some chipped edges	B-5, 6
Base-board	none		
Walls	granite	dirty, floor wax on lower edges	B-5, 6
Cornice	none		
Ceiling	vaulted plaster	some cracks, peeling paint; ivory, cream, pale grey paints	B-5, 6
Windows	none		
Window Frames	none		
Doors	exterior: oak interior: grained metal	exterior needs refinishing, interior some chipped and crazed areas, some dirt	B-6, 7, 8
Door Frames	same as above		
Hardware	exterior: brass interior: brass	highly polished tarnished	B-6, 7, 8
Elec. Fixt.	frosted glass globes		B-5, 6
Special Features

B-5; South corridor, looking north.

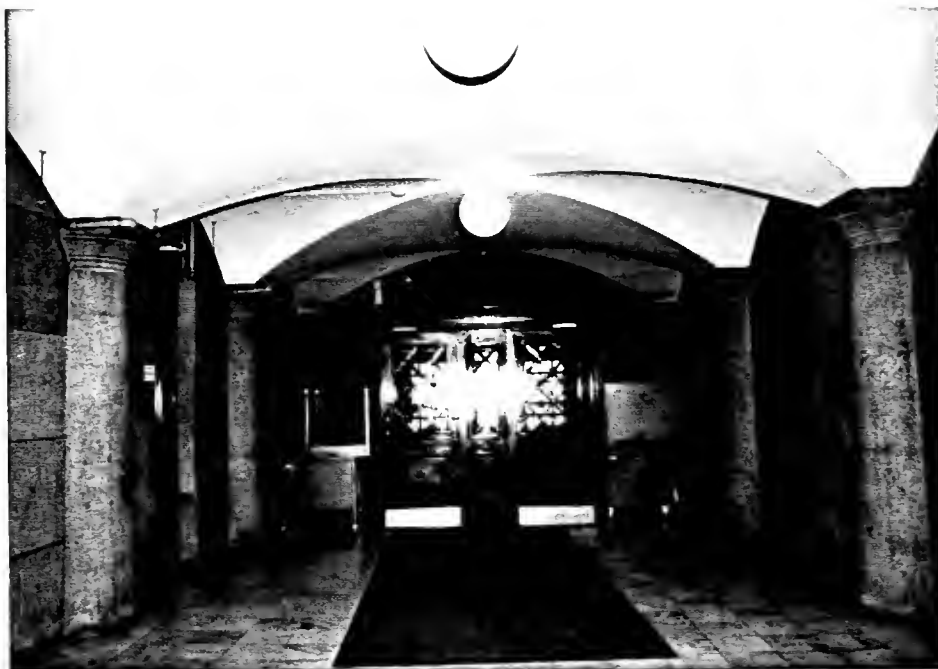
B-6; South corridor, looking south.

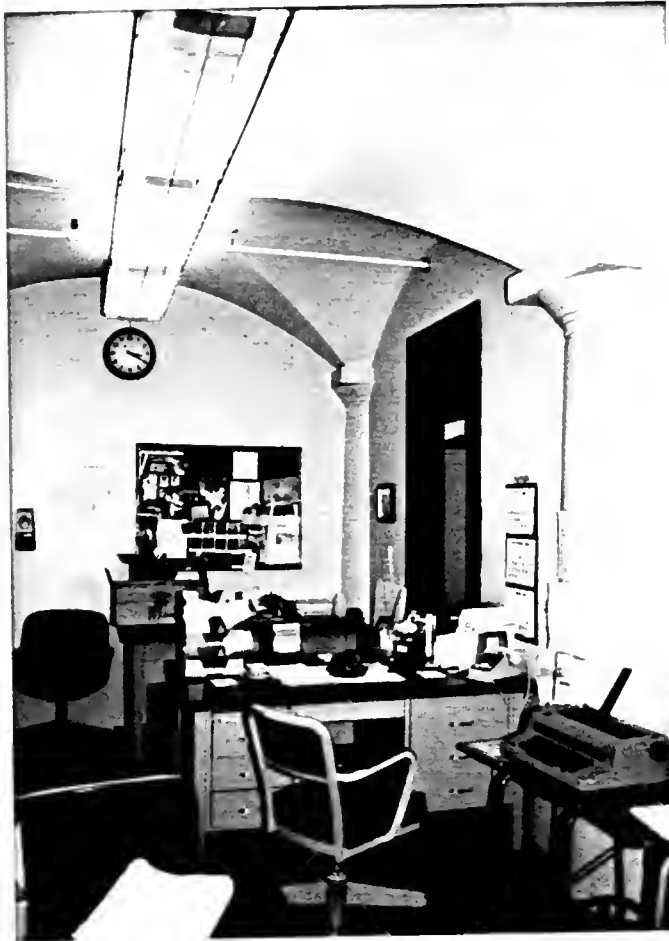
Element	Material/Description	Condition	Photo#
Floor	carpet over linoleum over granolithic (?)	fair	B-11, 12
Base- board	flat marble with black linoleum	some chips	
Walls	outer walls - granite; inner walls - plaster and metal	severe plaster and paint problems on south and west walls	B-11, 12
Cornice	picture rail	good	
Ceiling	plaster	water damage in large area, SW corner	B-11, 12
Windows	Kalamein	some corrosion, dirt	
Window Frames	grained metal	crazed and chipped in a few areas	
Doors	grained metal	(same as above)	
Door Frames	grained metal	(same as above)	B-8
Hardware	brass	tarnished	B-8
Elect. Fixt.			
Special Features	Small toilet room in NE corner of marble and porcelain	perfect shape	B-13
Remarks

Element	Material/Description	Condition	Photo#
Floor	carpet over linoleum (over granolithic ?)	poor	B-11, 12
Base-board	flat marble	covered with black linoleum	
Walls	outside wall granite inside walls plaster	granite - 15-17 layers* plaster has mustardy tan as first paint (10 layers)	B-11, 12
Cornice	picture rail only	good	
Ceiling	vaulted plaster	some peeling skim coat on S wall	
Windows	Kalamein	fari, some dirt	
Window Frames	grained metal	some dirt, chips	
Doors	grained metal	should be cleaned and re-varnished	
Door Frames	grained metal	(same as above)	
Hardware	brass	tarnished	
Elect. Fixt.	egg crate		
Special Features	transom lights of crinkle glass (one missing)

B-11; Southwest office suite, looking south.

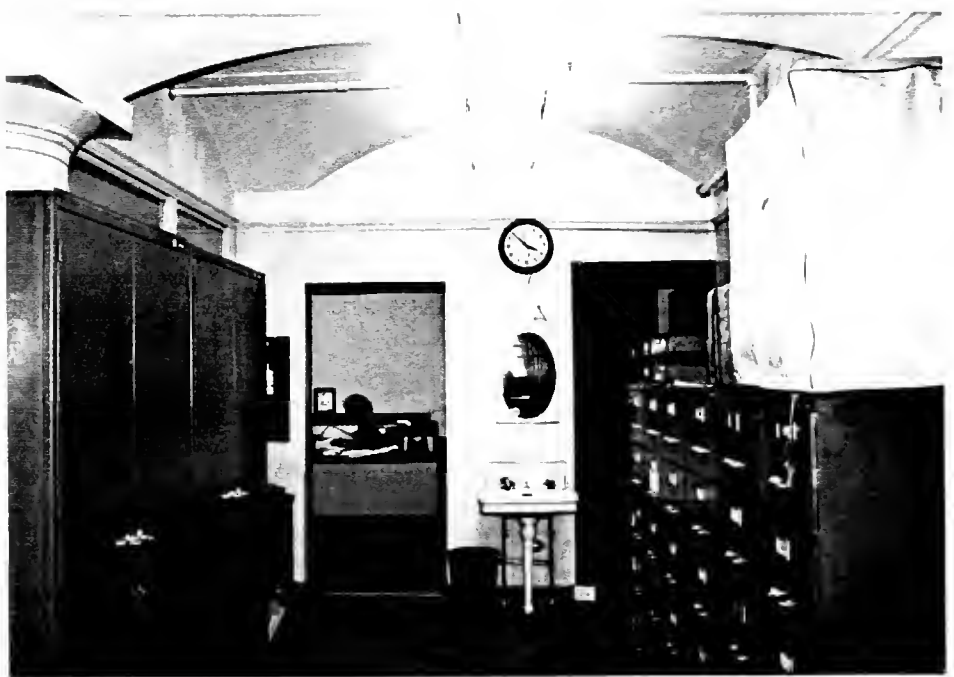
B-12; Southwest office suite, looking north.

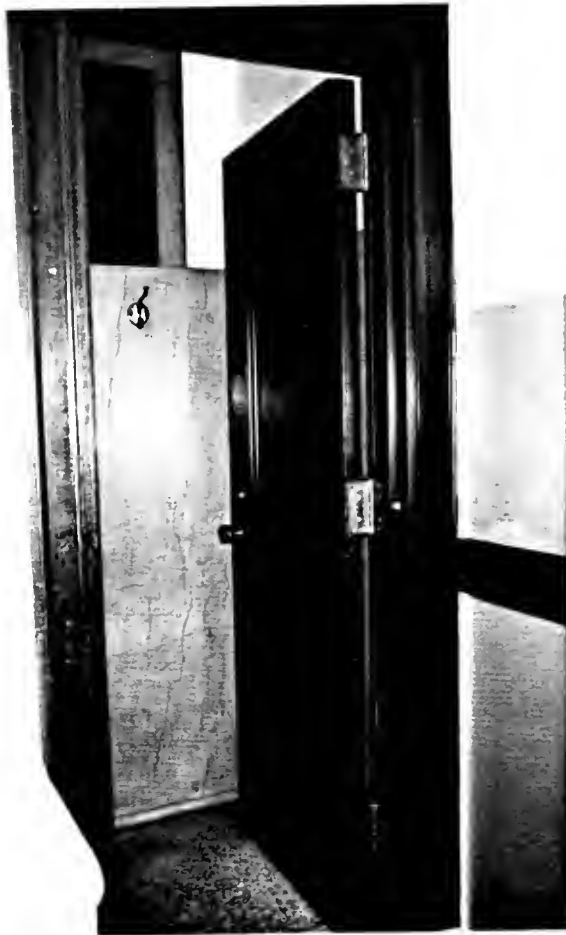
B-13; Lavatory with 1912 marble wainscoting and granolithic floor, southwest office suite.

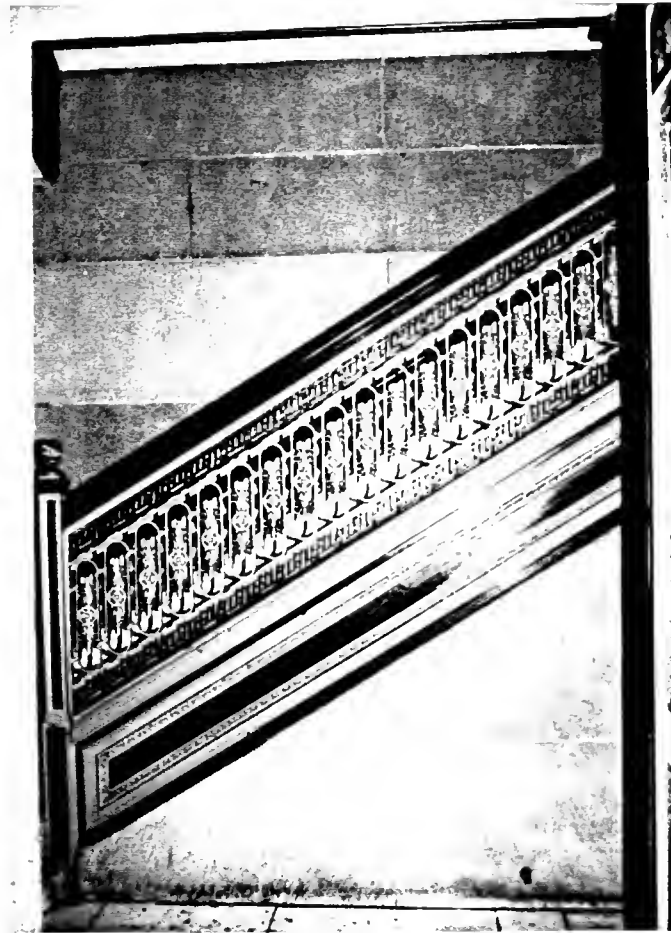
B-16; Stair balustrade.

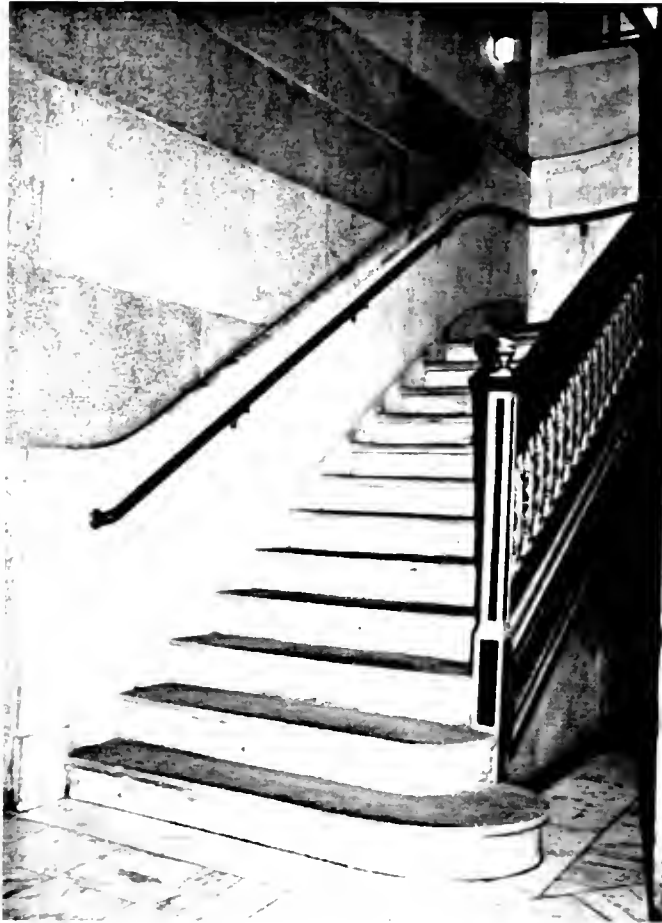
Element	Material/Description	Condition	Photo#
Floor	marble, granolithic	worn	B-17
Base-board	marble	soiled, slightly chipped	B-17
Walls	marble wainscot, granite above	very soiled, dulled by abrasive cleaning	B-17
Cornice	none		
Ceiling	flat plaster		
Windows	one, at turning of stair; Kalemein	dirty	
Window Frames	Kalemein		
Doors	none		
Door Frames	none		
Hardware	brass	tarnished	
Elect. Fixt.	frosted glass		
Special Features			
Remarks:	Granolithic treads on stairs are dull, worn and unsightly. Balustrade is iron and was originally painted bronze, black, deep green.

B-17; Stairs.

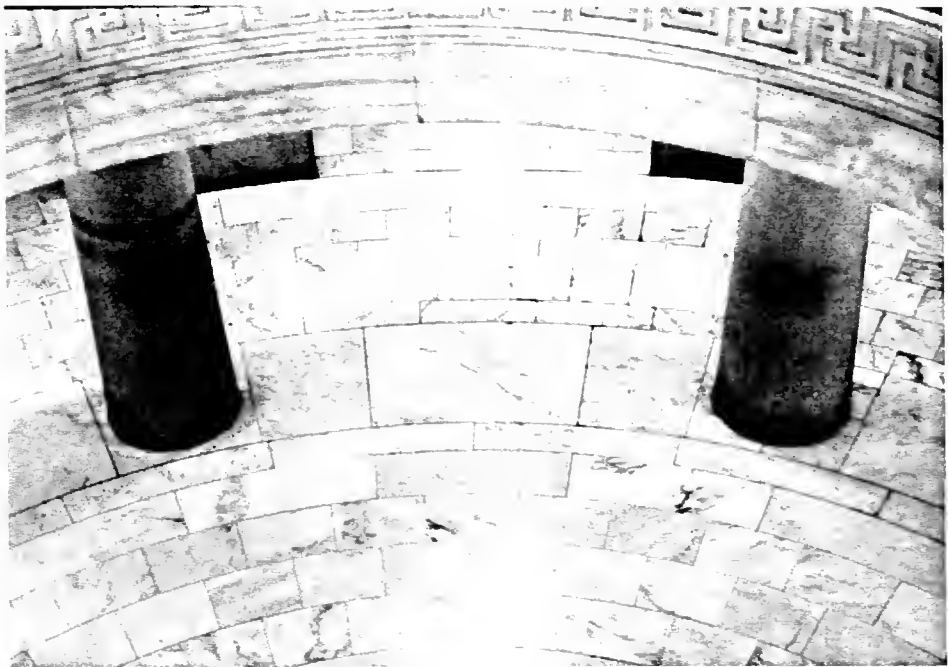
B-18; Floor of rotunda.

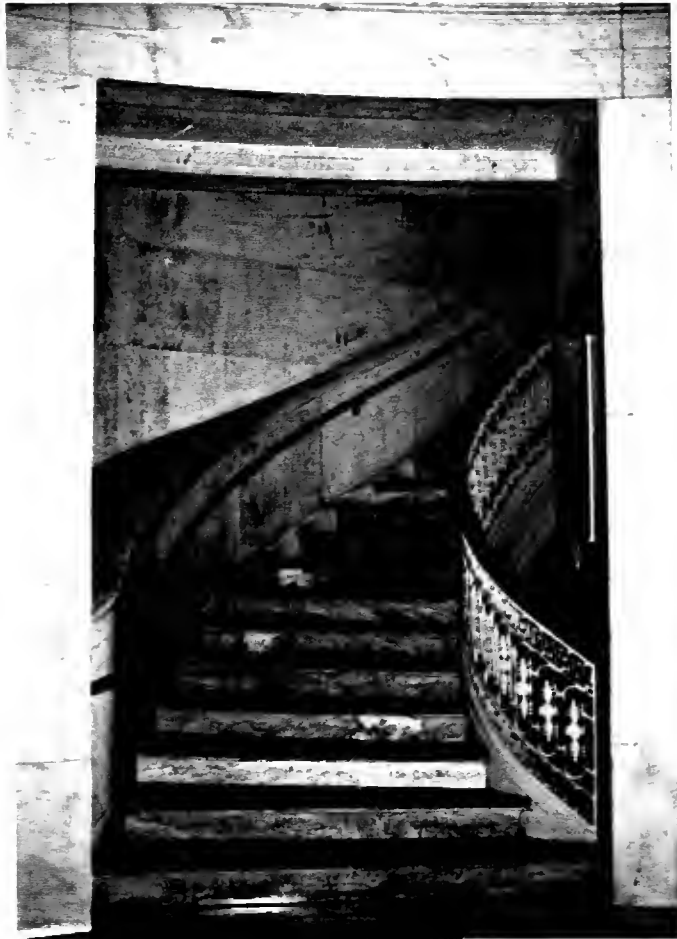
Element	Material/Description	Condition	Photo#
Floor	treads are marble with granolithic over	worn, dirty	1-6, 7
Base-board	marble, flat, part of wainscot	scoured, dirty	1-6, 7
Walls	marble	scoured, some dirt and streaks	
Cornice	none		
Ceiling	plaster	fine	
Windows	one Kalamein at turning of stair	dirty	
Window Frames	marble	dusty, rough	
Doors	none		
Door Frames	none		
Hardware	iron balustrade	repainted at least 3 times	1-6, 7
Elect. Fixt.			
Special Features	grille over window into elevator well	originally iron, painted pearl grey over red primer	1-8
Remarks

1-6; Stairs.

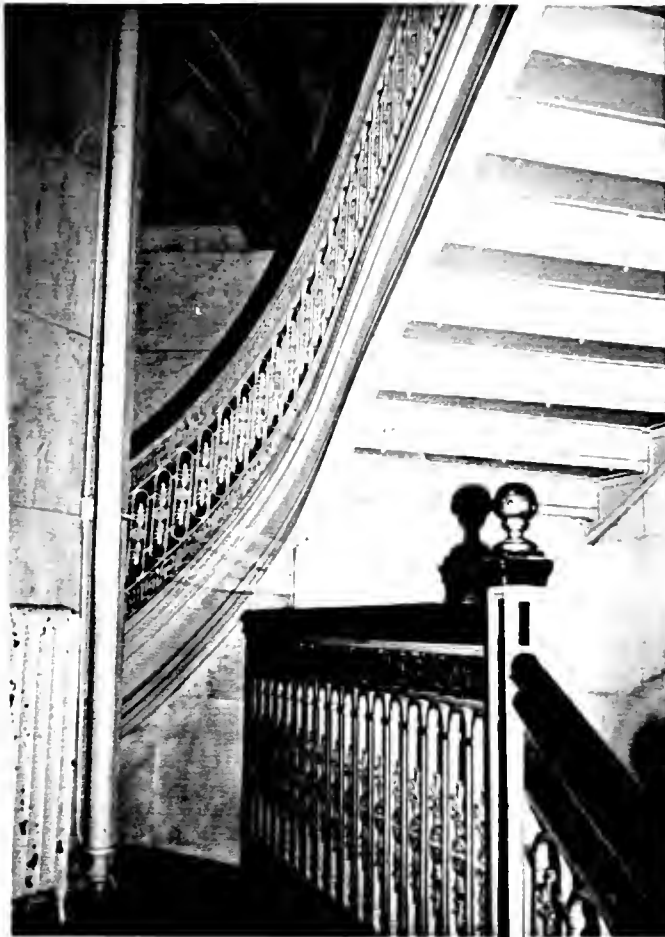
1-7; Stairs.

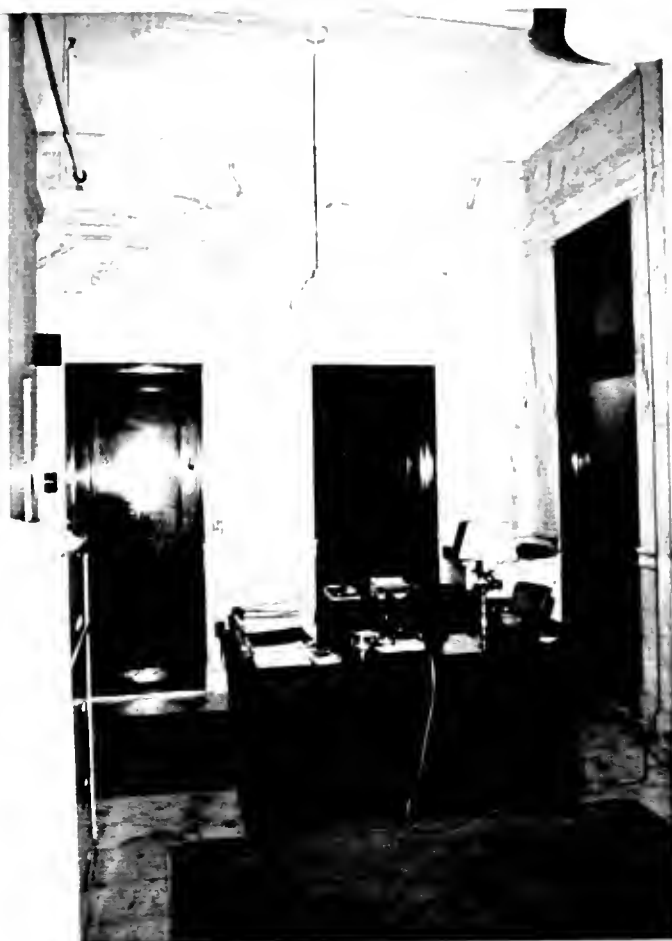
Element	Material/Description	Condition	Photo#
Floor	marble	good	1-9
Base-board	marble	some chips and scratches	1-9
Walls	marble	well polished and clean above wainscot, 1-9 scoured below	
Cornice	plaster	good	1-9
Ceiling	molded plaster panels	good	1-9
Windows	none		
Window Frames	none		
Doors	grained metal	good - minor touch-up needed	1-9
Door Frames	grained metal	(same as above)	1-9
Hardware	brass	dull	
Elect. Fixt.	hanging frosted glass	good	1-9
Special Features

1-9; Lobby, north wing.

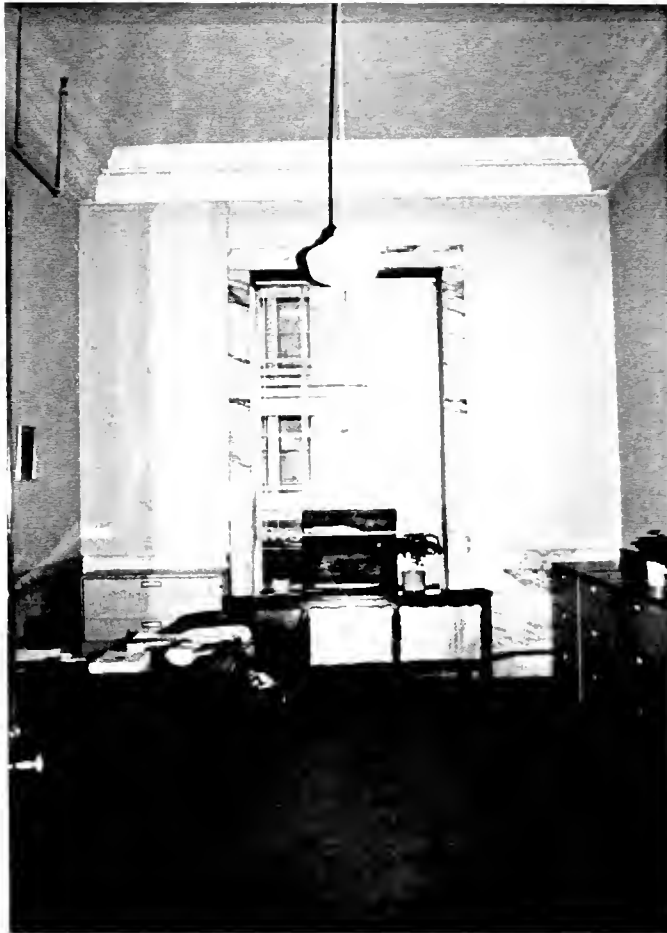
Element	Material/Description	Condition	Photo#
Floor	carpet over ?	good	1-10
Base-board	marble	good	1-10
Walls	marble wainscot, plaster	some minor dirt, abrasion	1-10
Cornice	plaster	good	1-10
Ceiling	flat plaster	good	1-10
Windows	steel factory sash	poor, rusted	1-10
Window Frames	flat marble	good - some minor dirt	1-10
Doors	grained metal	good	
Door Frames	grained metal	good	
Hardware	brass	dull	
Elect. Fixt.	c. 1940 hanging frosted glass	good	
Special Features			
Remarks

1-10; Customs secretary's office.

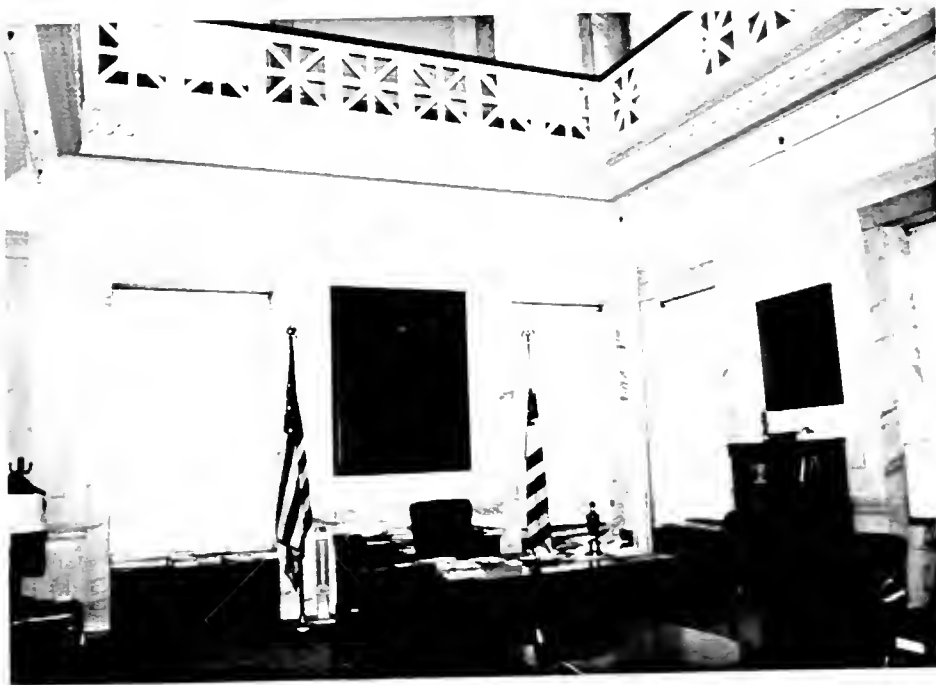
Element	Material/Description	Condition	Photo#
Floor	marble, carpeted over marble ?	slightly dirty, scarred	1-11
Base-board	marble	slightly dirty & scarred	1-11, 12, 14, 16, 17, 18
Walls	marble, wainscot, moulded plaster above		
Cornice	moulded plaster	fine, except East wall	1-11, 13, 15, 16, 18
Ceiling	vaulted plaster	fine, <u>except</u> East wall	1-18
Windows	steel frame sash	rusted on exterior	1-11
Window Frames	marble	need cleaning	1-11, 16, 17
Doors	grained metal	good	1-12
Door Frames	grained metal	good	1-12
Hardware	brass	dull	
Elect. Fixt.	painted metal	good	1-13, 14
Special Features			
Remarks: Director's Private Office is simple and in very good condition (see photo 1-20).

1-11; Director's office, looking north.

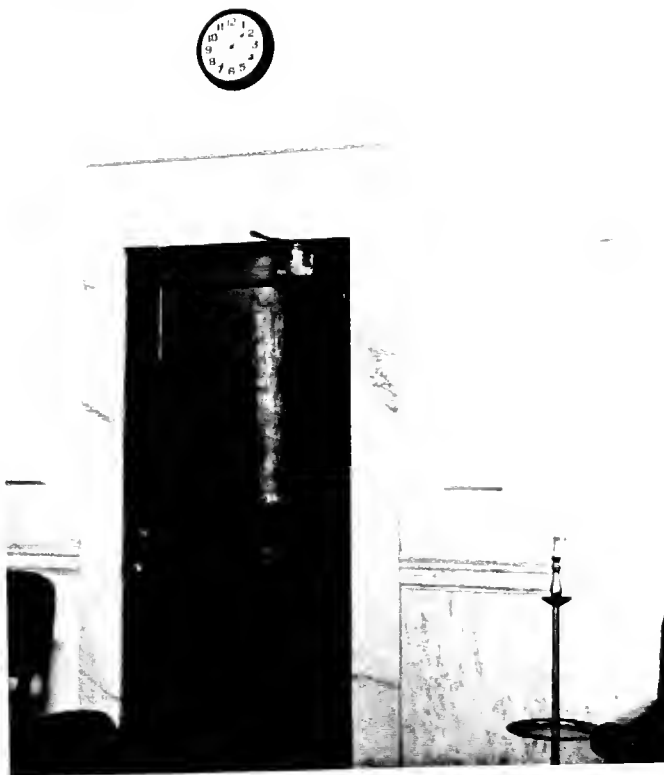
1-12; Director's office, south wall.

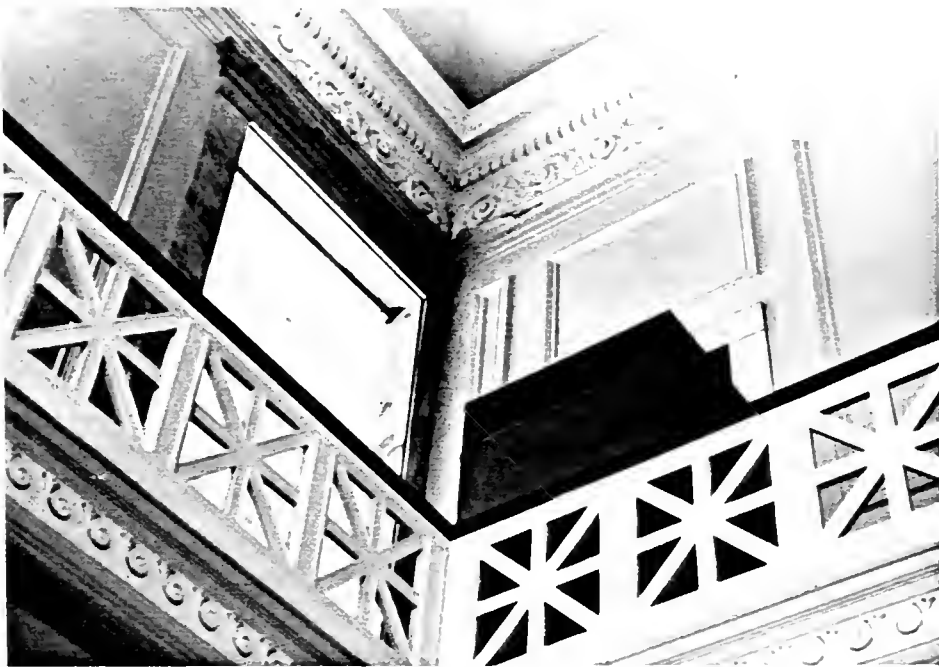
1-15; Director's office, southeast corner.

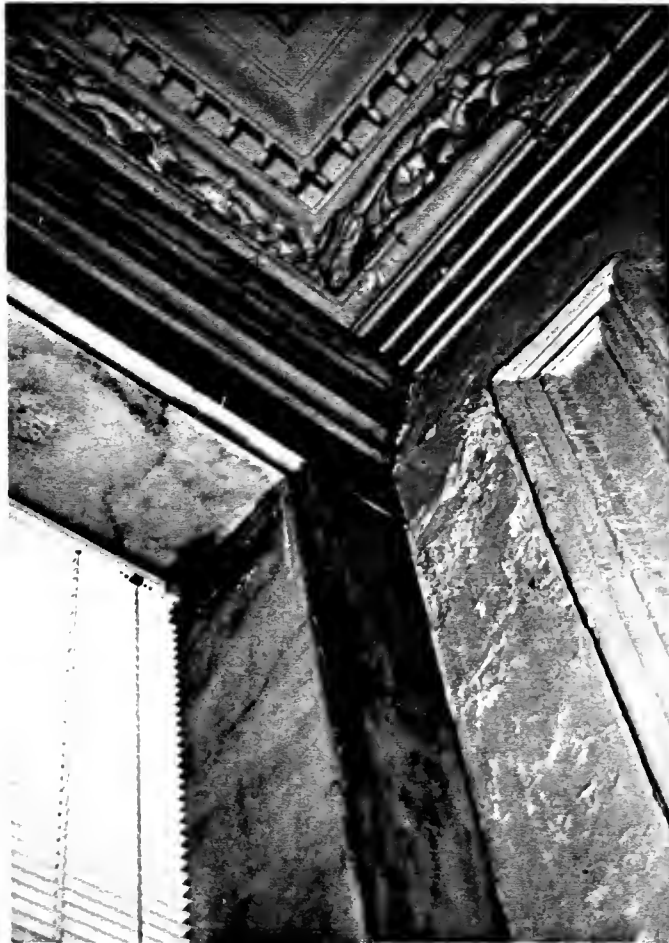
1-16; Director's office, detail, southeast corner.

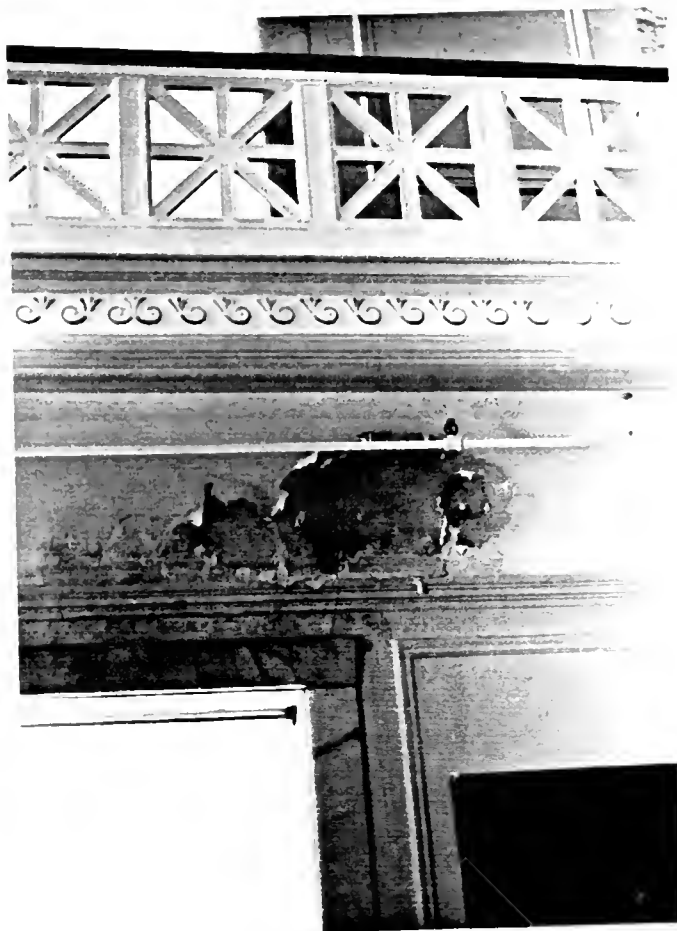
1-17; Director's office, north wall.

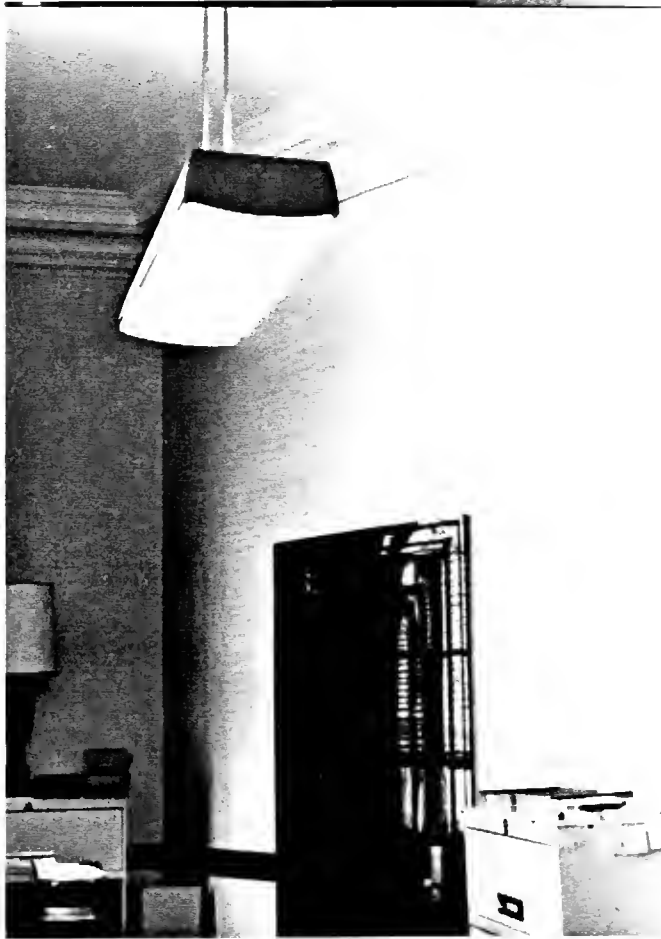
1-20; Director's private office.

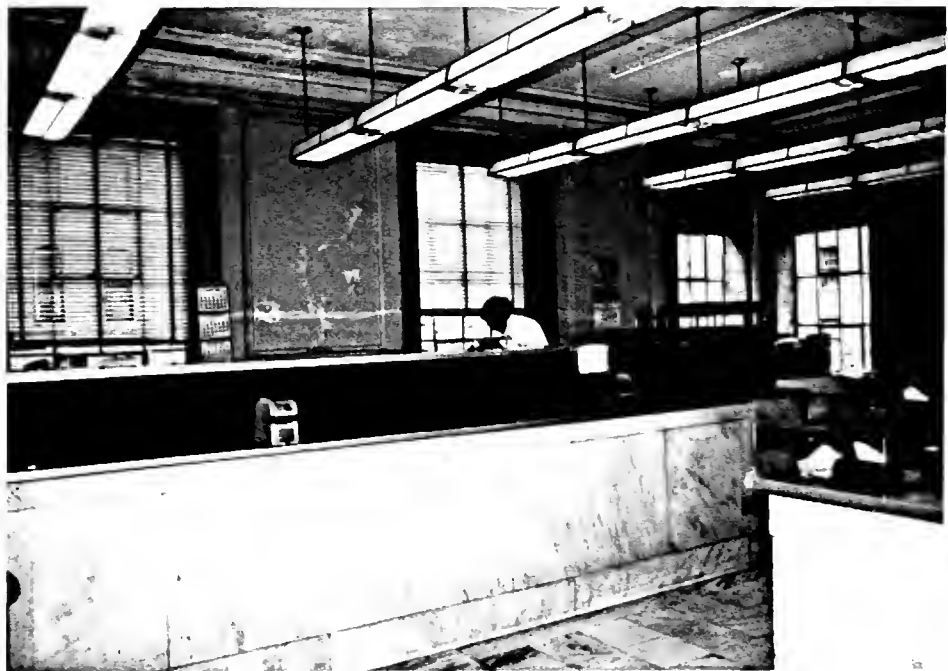
Element	Material/Description	Condition	Photo#
Floor	marble, carpet over in W	good	1-22
Base-board	marble	dirty, scratched	
Walls	marble wainscot plaster w/ panel molding	dirty, scratched some chips, E wall poor, W wall center poor	1-22, 23
Cornice	plaster	good except on E wall	1-22, 23
Ceiling	plaster - some coffering	good except E by center window	1-24
Windows	steel frame	dirty, rusted	1-22, 23
Window Frames	marble	dirty, some scratches	1-22, 23
Doors	painted metal glazed grille	need cleaning and paint touch-up	
Door Frames	grained metal	(same as above)	
Hardware	brass	dull	
Elect. Fixt.	egg crate		1-22, 23, 24
Special Features			
Remarks

1-22; South wing.

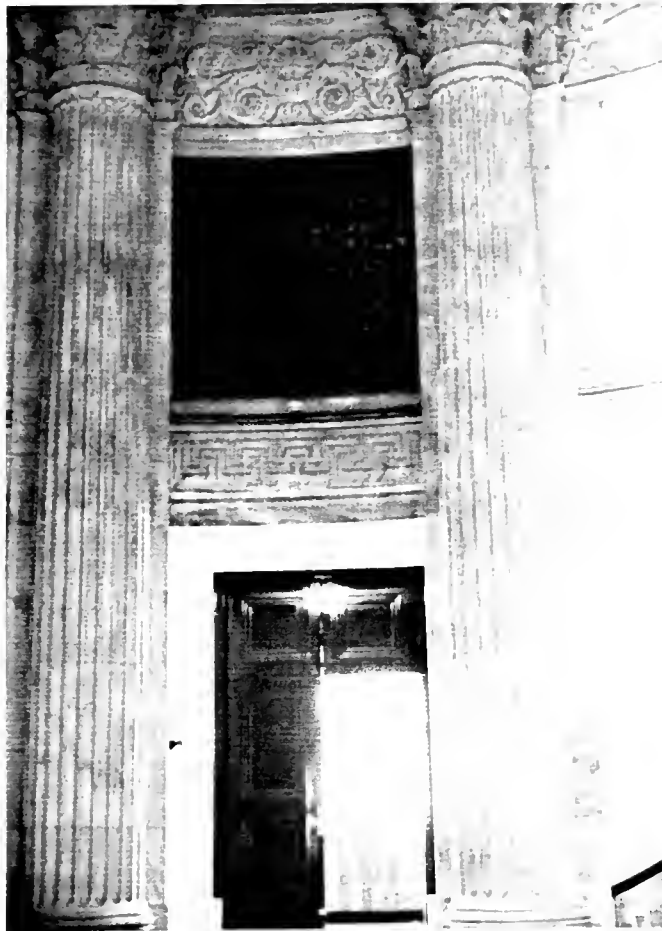
Element	Material/Description	Condition	Photo#
Floor	marble	highly polished, joints blackened, good condition	
Base- board	none		
Walls	marble	stained and soiled - evidence of coating gone yellowish - dull surface	2-1, 17
Cornice	plaster, unpolished marble in E & W niches	somewhat dirty, but good	2-17
Ceiling	dome	in W niches peeling badly	
Windows	none		
Window Frames	none		
Doors	grained metal	need cleaning & touch-up	2-5
Door Frames	marble	good - some chipping & soiling	
Hardware	brass	good, but dull	
Elect. Fixt.	hanging frosted spheres		2-4
Special Features

2-1; Rotunda, looking south.

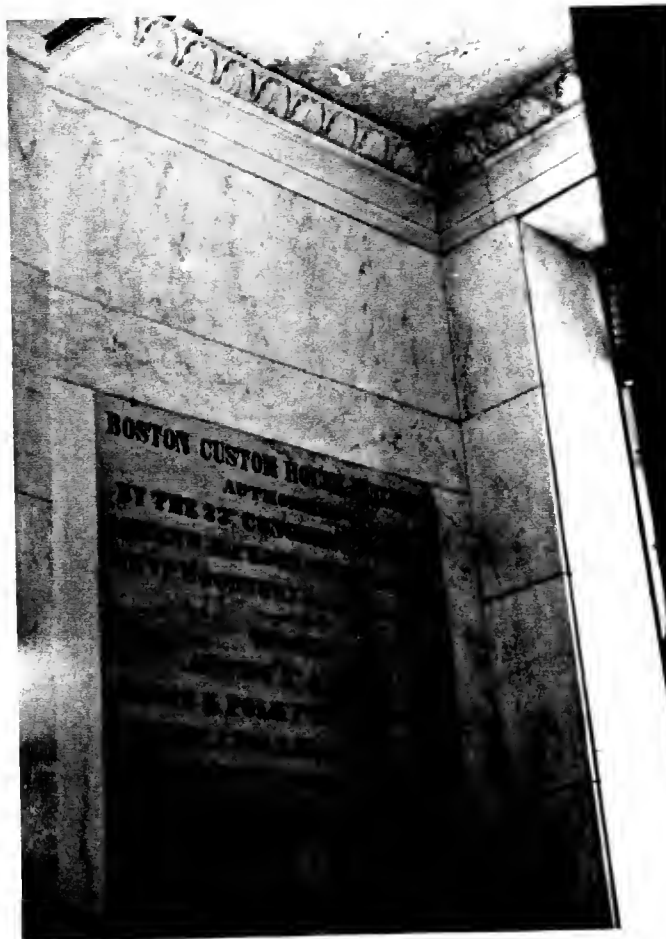
Element	Material/Description	Condition	Photo#
Floor	marble, marble steps	dirty	
Base-board	marble	dirty, dusty	
Walls	marble	slightly dirty	2-2
Cornice	marble	dusty	2-2, 3, 4
Ceiling	plaster	water damage, cracks	2-2, 3
Windows	Kalamein	dirty, some corrosion and streaks	
Window Frames	marble	dusty	
Doors	none		
Door Frames	none		
Hardware	none		
Elect. Fixt.	frosted spheres		
Special Features	W alcove has marble plaque identifying original Custom House	Black paint in letters is peeling	2-2
Remarks

2-2; Plaque, west window alcove.

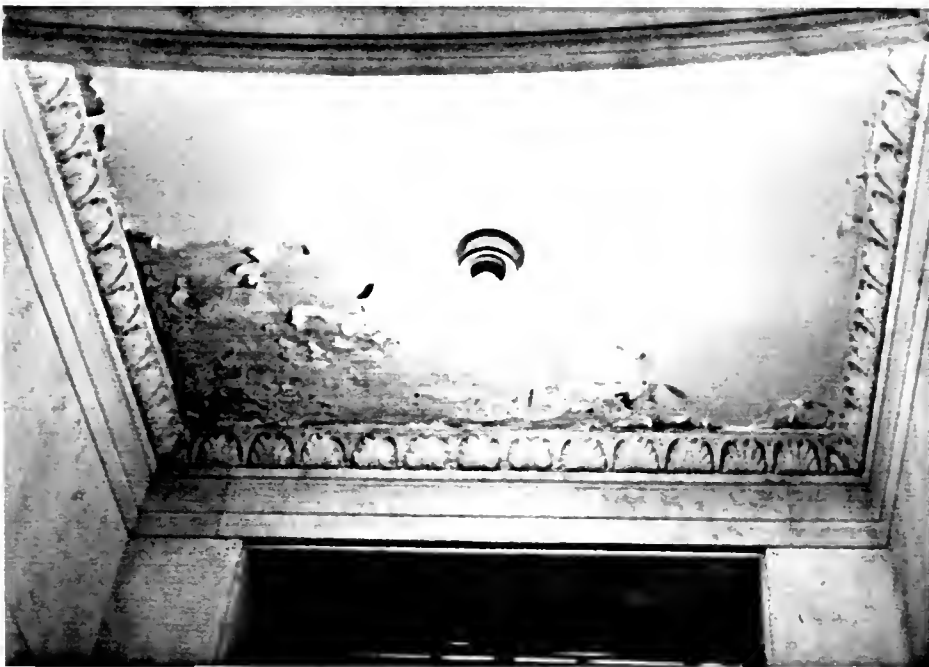
2-3; Ceiling in west window alcove.

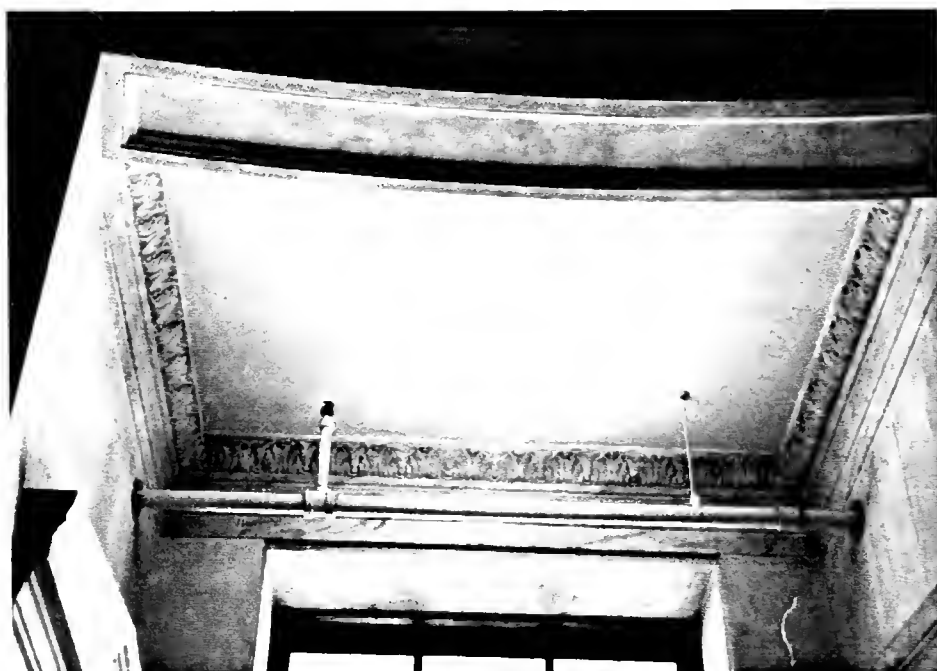
2-4; East window recess, ceiling.

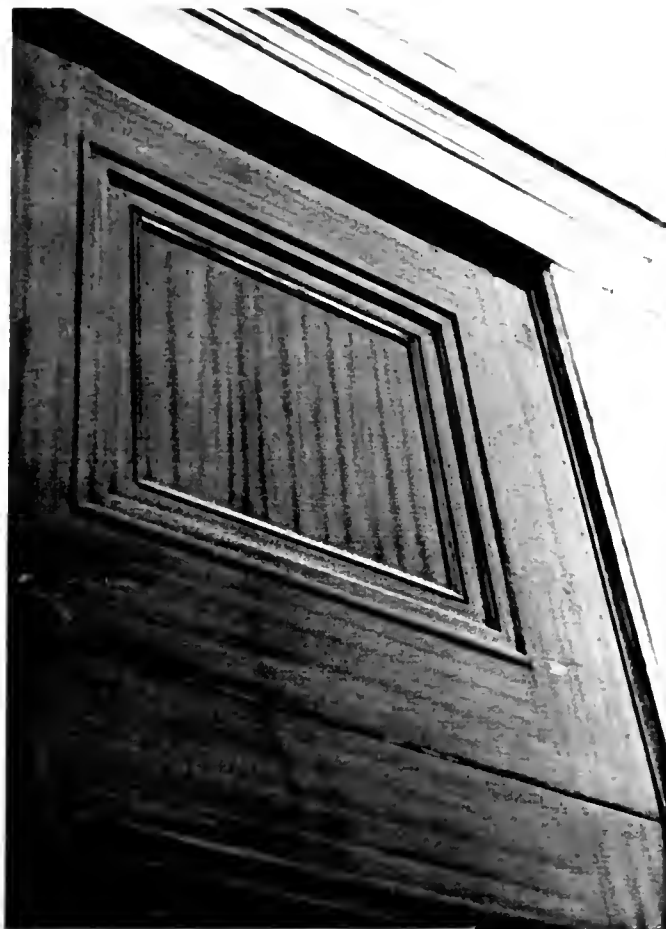
Element	Material/Description	Condition	Photo#
Floor	marble	good, slightly scratched, joints dark	
Base-board	marble, molded	minor nicks and scratches	
Walls	marble, paneled plaster	some soiling, abrasion on marble; plaster is good	2-6
Cornice	molded plaster	good, dusty	2-7
Ceiling	coffered plaster	good	2-7
Windows	frosted glass in metal	good, slightly dirty	2-6
Window Frames	grained metal	good, minor nicks	2-6
Doors	grained metal	good, minor scratches, chips	2-5
Door Frames	grained metal, marble	good	2-5, 6
Hardware	brass	tarnished	
Elect. Fixt.	egg crate		
Special Features			
Remarks

2-5; Detail, door to north wing.

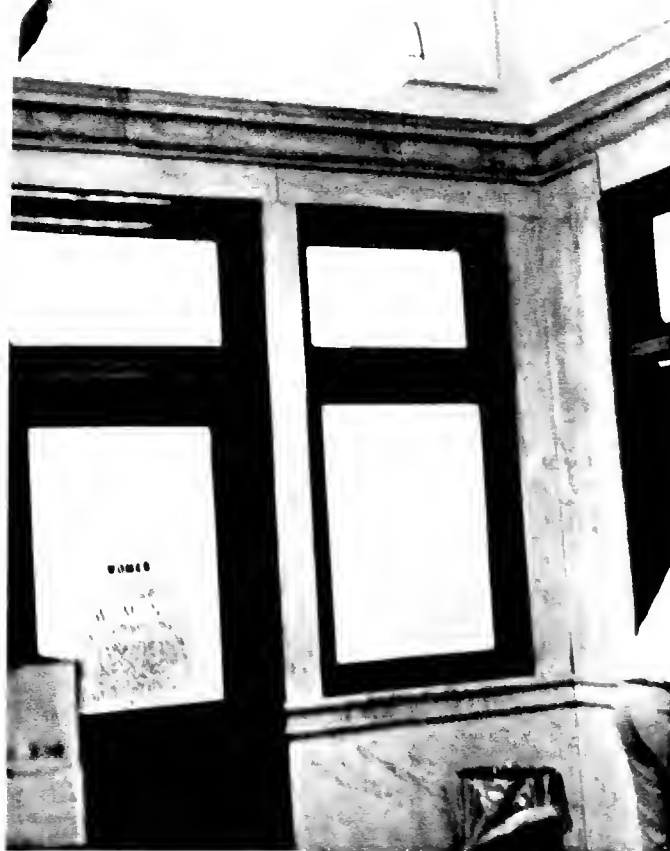
2-6; Lobby, north wing.

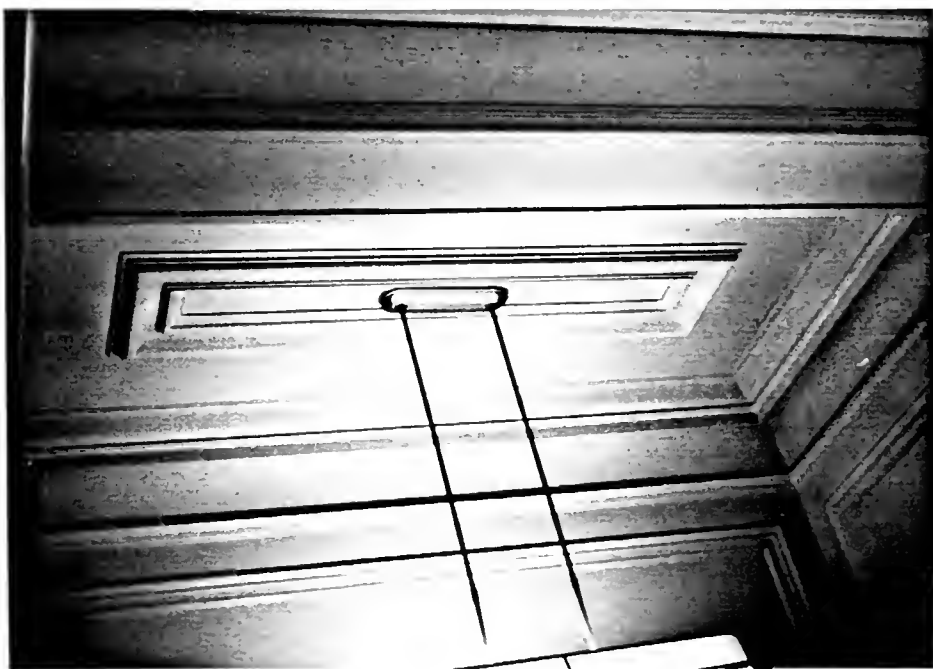
2-7; Ceiling in Lobby, north wing.

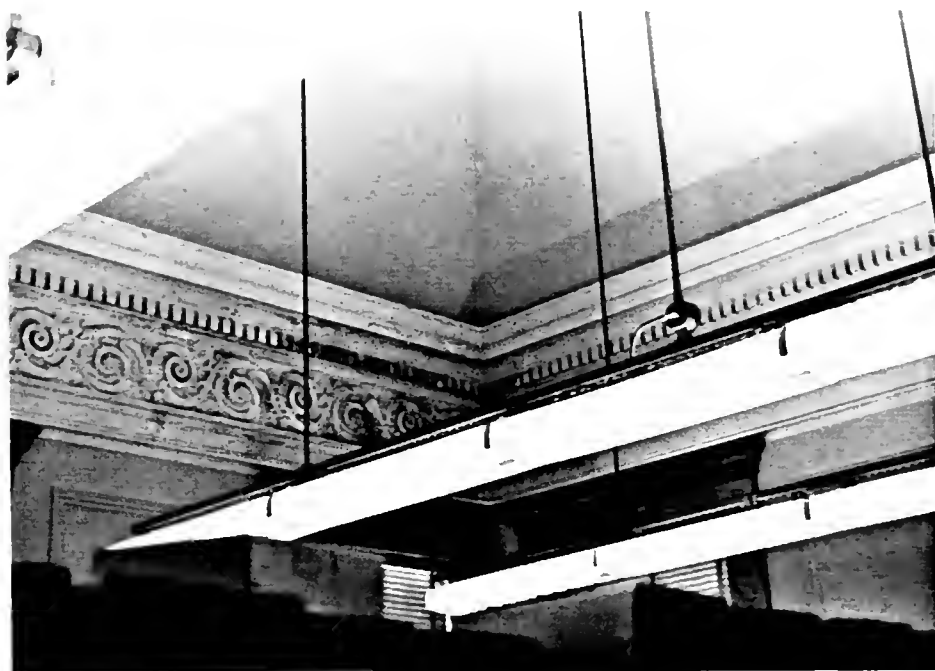
Element	Material/Description	Condition	Photo#
Floor	carpet over ?	poor	
Base-board	marble, molded	scratched & dirty - fair	2-14, 15
Walls	paneled plaster over low marble wainscot	some dirt, scratches, chips, abrasion	2-14, 15, 16
Cornice	molded plaster and rinceau	NE & NW corners - missing - much water damage	2-9
Ceiling	coved plaster	good except small spot in center & NE & NW corners, and N side	2-9, 10, 11, 12, 13
Windows	steel sash	corroded	
Window Frames	marble	soiled, dull, nicked	2-9, 11, 13
Doors	grained metal	painted over on rotunda side; needs cleaning and touch-up	
Door Frames	grained metal architraves	need cleaning and touch-up	
Hardware	brass	dull	
Elect. Fixt.	egg crate		2-9
Special Features			
Remarks

2-9; Ceiling - Auditor's room, south wing, southeast corner.

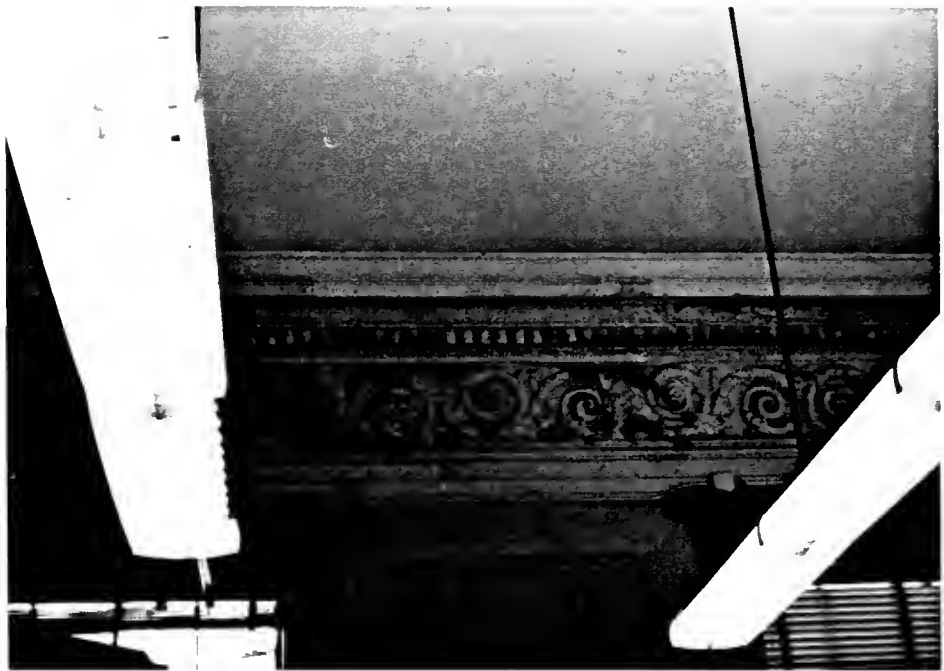
2-10; Auditor's room, south wing, east wall.
